Manhole Inspection Summary

Manhole # S19AA2057MH

Location Address: **ROGERS AVE**

Cross Street: **NORTHERN PKWY**

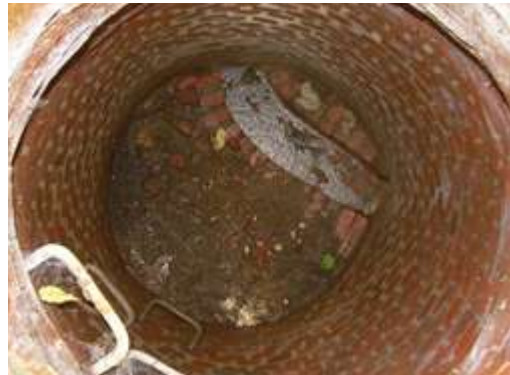
Top View

Evidence of surcharge - Bench debris.
Channel debris.

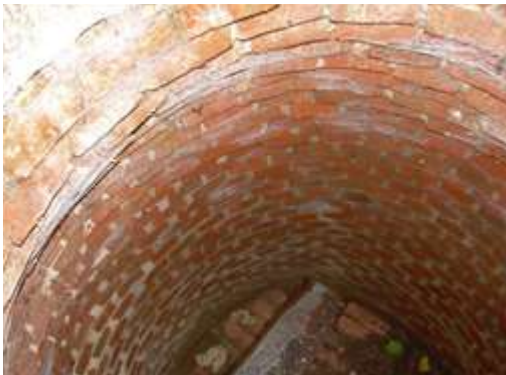
Defect

Corbel and Barrel infiltration.

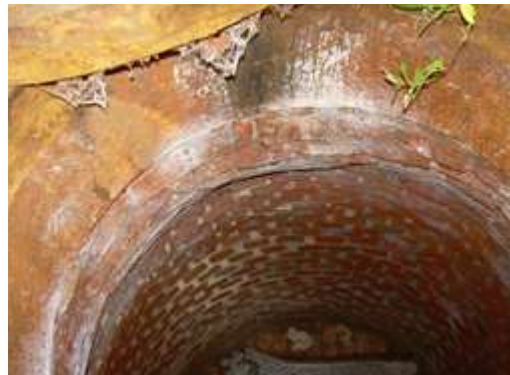
Defect

Frame leaks. Corbel and Barrel infiltration.

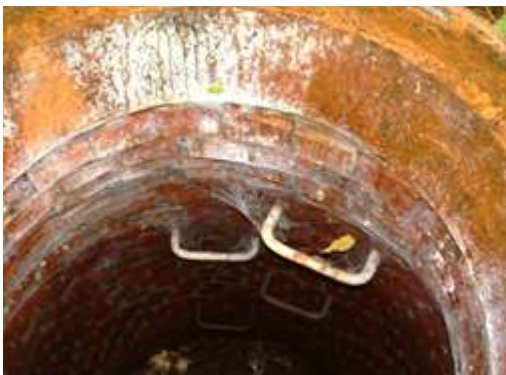
Defect

Corbel and Barrel infiltration.

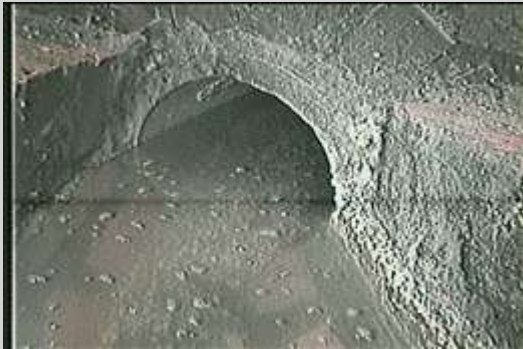
8 in. Circular Gravity Sewer Pipe Out @ 12 O'Clock

Deposits: ☐ None ☒ **Mud** ☐ Sludge ☒ **Debris** ☐ Grease

Silt Depth: **2** (in.) Deposits Extent: **Light**
